2021 CCR SURFACE IMPOUNDMENT ANNUAL INSPECTION REPORT

Big Cajun II Power Plant Pointe Coupee Parish, Louisiana

Cleco Cajun, LLC
10431 Cajun II Road, Highway 981
New Roads, Louisiana 70760

Geosyntec Consultants, Inc.
5420 Corporate Boulevard, Suite 202
Baton Rouge, Louisiana 70808

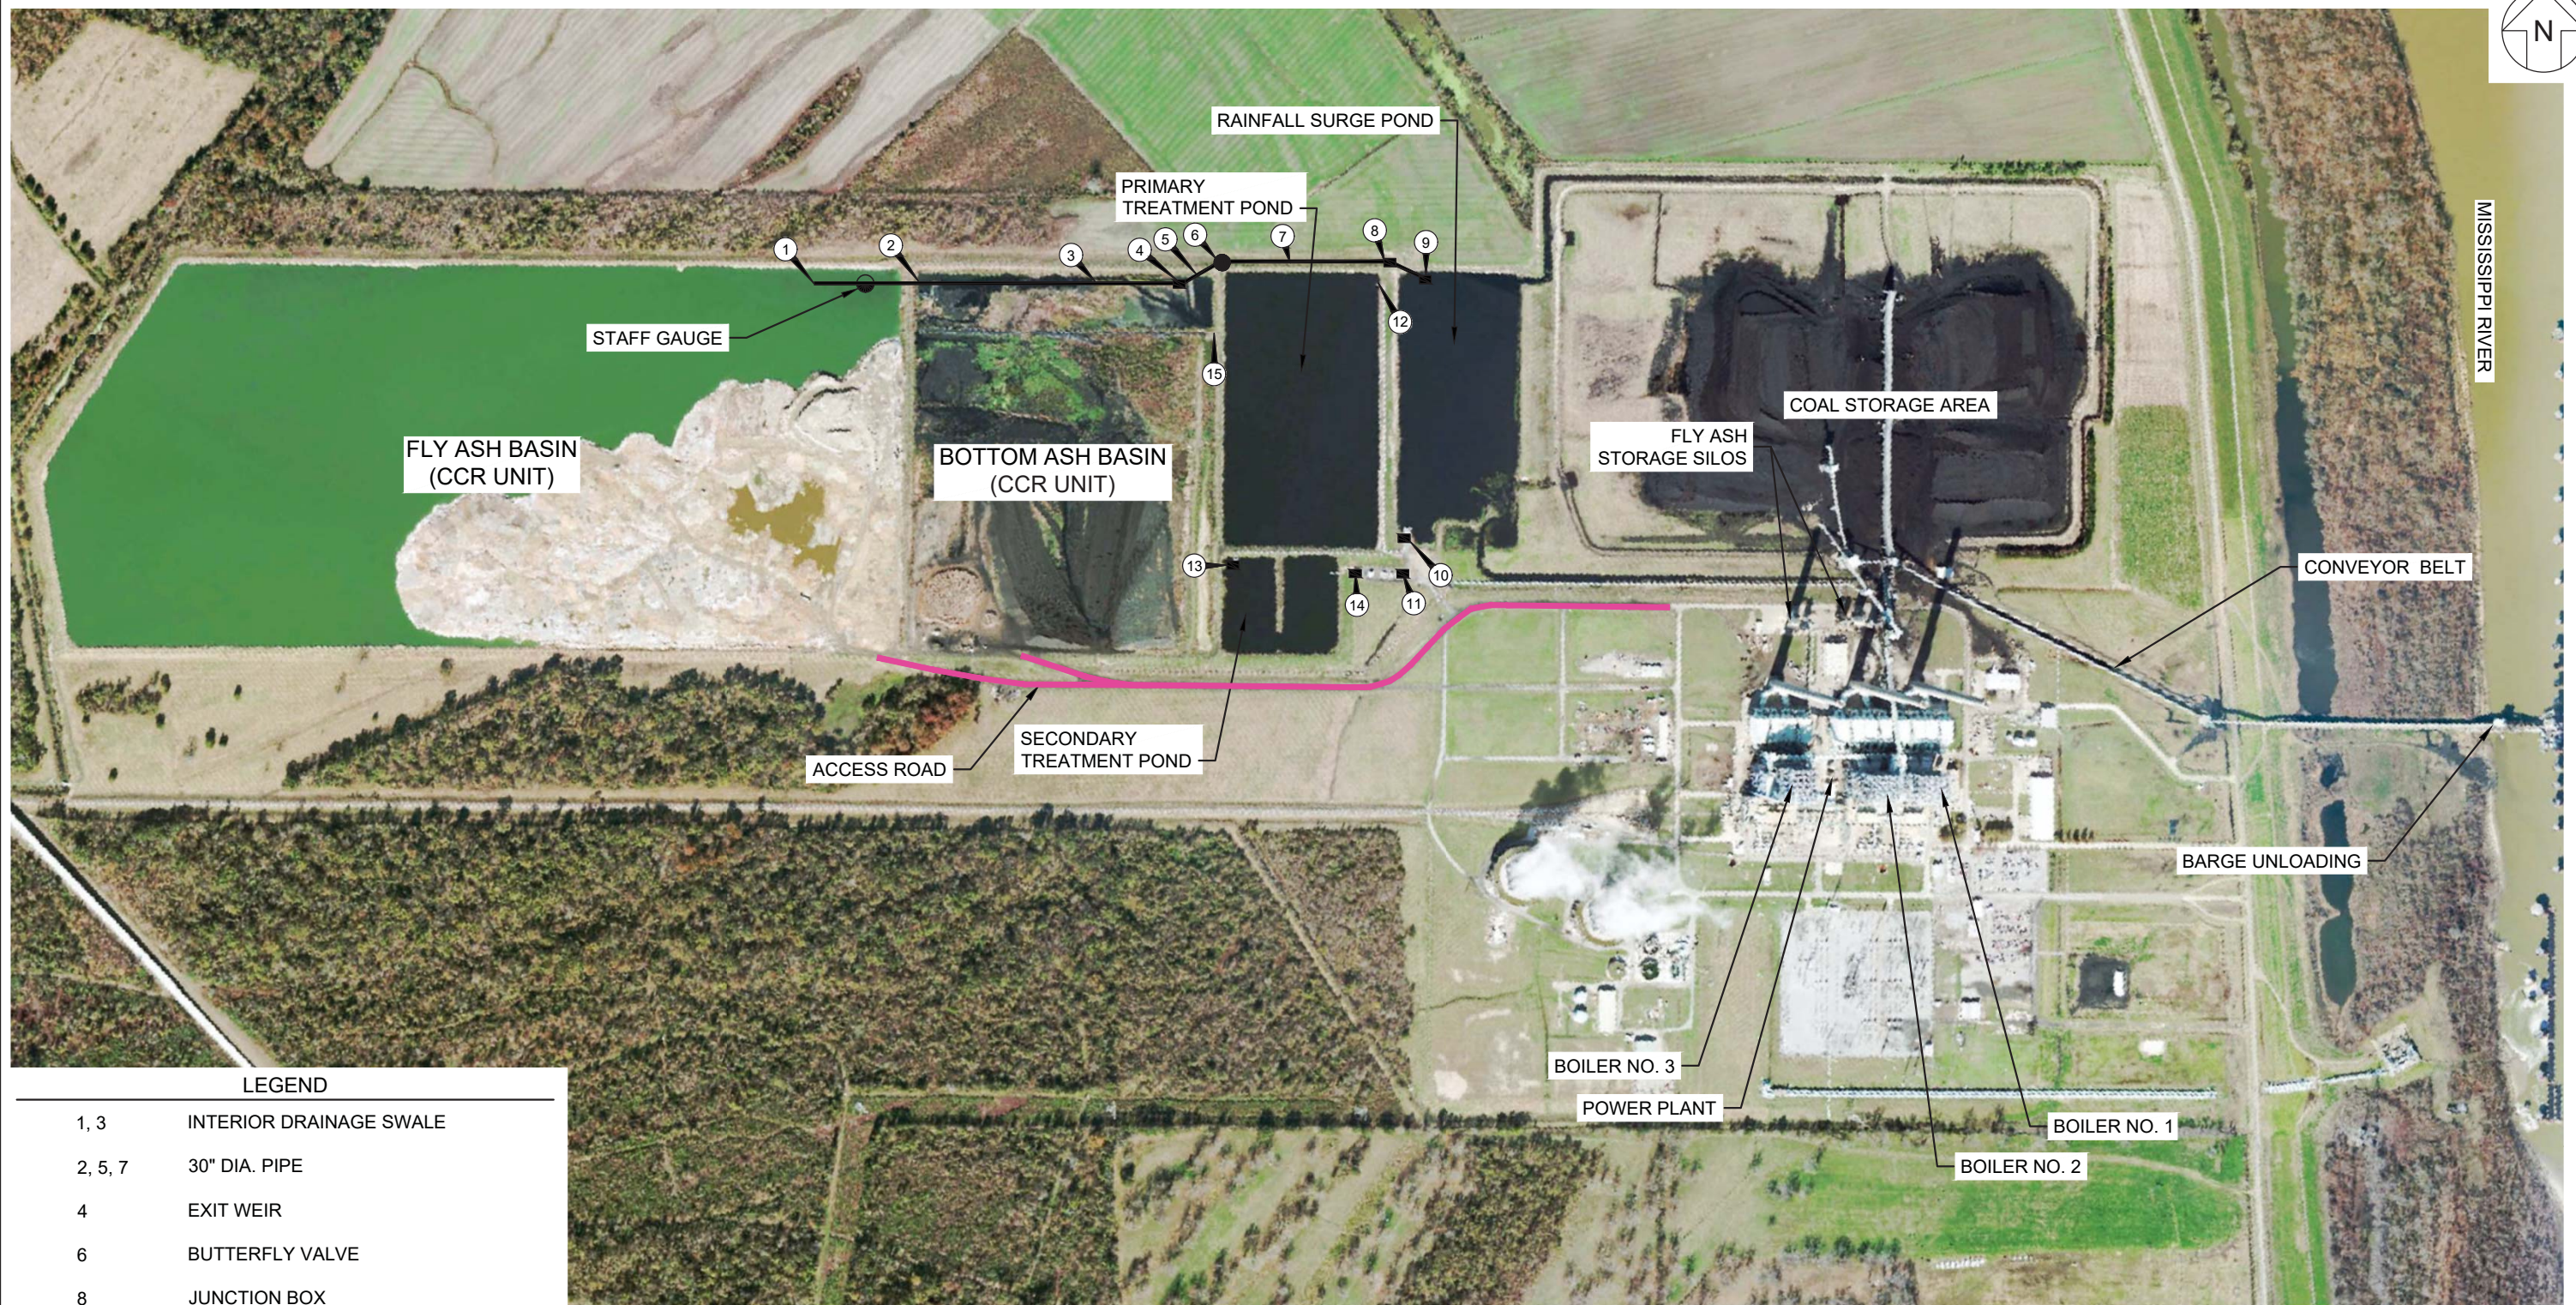
Water from the Fly Ash Basin is transported into the Bottom Ash Basin via a 30-inch diameter drainage pipe (see Figure 1). The combined flow from both CCR units is then directed through another 30-inch diameter drainage pipe and flow control valve into the Rainfall Surge Pond. Additional storage capacity is provided in the Bottom Ash Basin which is connected to an overflow weir (i.e., pipe) with concrete headwalls which can direct overflow water into the Primary Treatment Pond. At the time of inspection, the following observations were made:

- The staff gauge located at the northeast corner of the Fly Ash Basin was functional, with a depth reading between 1.25-ft and 1.5-ft, approximately 1.3-ft.

- Near the staff gauge location, the discharge pipe and headwalls were observed to be partially submerged and appeared to function as designed between the Fly Ash Basin and Bottom Ash Basin. Erosion, scour, or seepage at or adjacent to the pipe penetration was not observed.

- The Primary Treatment Pond and Bottom Ash Basin surface water elevations were observed to be below the pipe invert between the pond and basin, and surface water was not observed to overflow between the units at the time of visit. The exposed portion of the pipe appeared to be rusted in spots but intact and functional. A small gap between the dike and headwall was observed on the Primary Treatment Pond but was likely due to isolated erosion in the area.

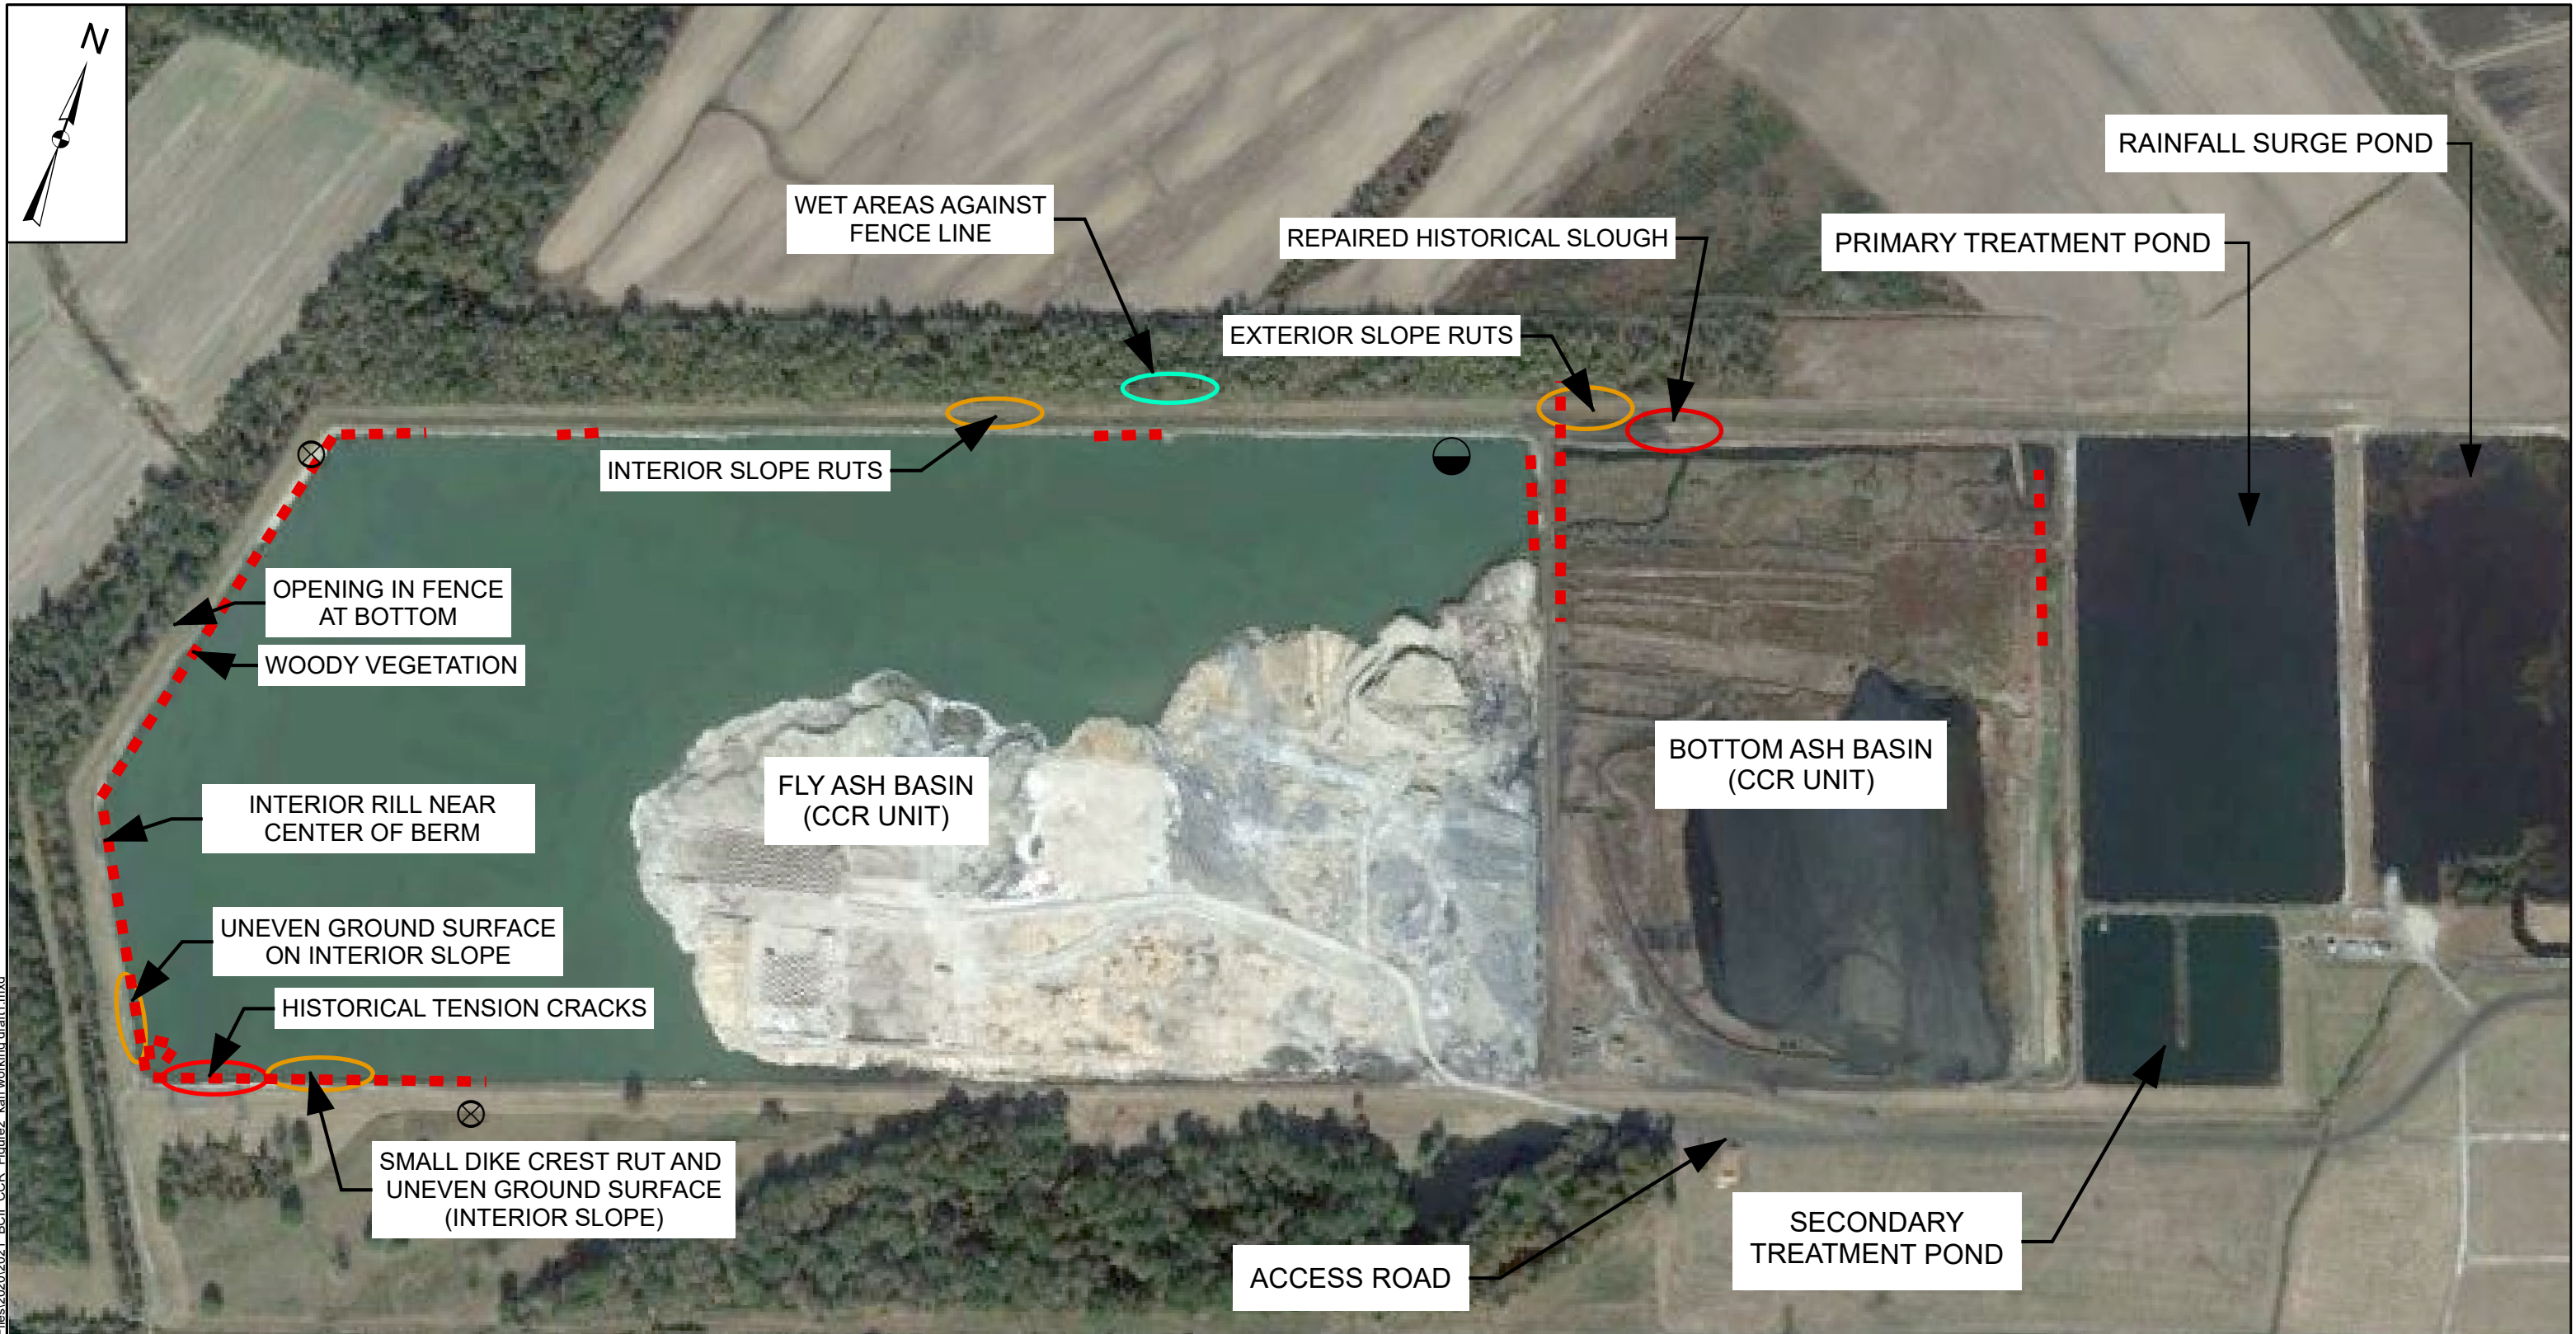
- A historical location of localized slope instability (a localized slough) on the north-facing exterior dike slope of the Bottom Ash Basin, about 400 feet east from the northwestern corner was identified during past annual inspections (CB&I, 2017; Geosyntec, 2018; Geosyntec, 2019; Geosyntec, 2020). The dimensions of the historical instability were approximately 70-ft to 90-ft long and exhibited a roughly 12-inch escarpment at the crest, that was slightly eroded with some vegetation growth. In January 2020, the Facility notified Geosyntec that a repair of this area was completed in December 2019. The repaired area does not appear to be displaced at the time of the inspection. Weekly inspection records indicate that the historical slough is monitored routinely, with no further evidence of displacement. At the time of the inspection, CCR material or a significant volume of standing water was not observed to be impounded on the interior perimeter dike slope adjacent to this area. As such, the former historical instability area appears to be a localized observation, that appears to have been adequately repaired prior to the 2020 annual inspection; and therefore, the area is not considered an issue that impairs the operation or safety of the CCR unit at this time.

- Overall, vegetation was observed to be in good condition, with no observed areas of significant distress and no signs of erosion of the exterior dike slopes or seeps exiting the slope. Adjacent to and west of the historical slough, rutting was observed in the

downstream dike slope, which appeared to be associated with tractor style mowing equipment used to maintain vegetation on the slope.

- Woody vegetation was observed on the interior of the berm on the northwest and northeast sides of the Bottom Ash Basin. Woody vegetation has the potential to lead to pathways of infiltration through the berm, reducing the berm's structural integrity. However, at the time of the 2021 annual inspection, evidence of pond water infiltration through the berm was not observed. Woody vegetation is recommended to be removed from the interior of the berm as practicable and the localized area recompacted after vegetation has been removed.

- Wet areas were indicated in the *2018 Annual Inspection Report* (inspected in October 2017) [Geosyntec, 2018]. These wet areas were previously identified on the Fly Ash Basin perimeter south dike toe about 1,300 feet and 2,000 feet west from the southeastern corner and were not observed to contain standing water during the 2021 inspection. The natural topography indicates that these are low-lying areas where water tends to naturally accumulate. Seepage of the perimeter dike structure or signs of distress or malfunction were not identified.

- Limited areas of ponded water were observed on the north side of the Fly Ash Basin against an existing fence line. Topography north and outside of the fence line is slightly higher and prevents surface water runoff. The adjacent downstream dike slope was observed to be dry; as such, the retained water does not appear to be the result of seepage through the containment structures.

- Surficial material on the interior slopes in several areas of the southwestern, western and northwestern dikes appear to be uneven resulting in localized steeper slopes near the crest. In some cases, rills extend near to the interior dike crest edge and/or are partially concealed by grassy vegetation. Maintenance of grassy vegetation on the interior slopes, further observation to identify changes, and/or regrading activities to smooth the interior slope is recommended.

- An area of uneven ground surface or a tension crack along the exterior about 250 feet east of the southwestern corner was observed in prior annual inspections. The southwest corner of the Fly Ash Basin was also previously identified as having potential sloughs/slope instability and was subsequently repaired. During this inspection, evidence of movement or instability (e.g., seepage, wet areas, and additional slumping) was not observed. The area merits continued annual inspection and observation weekly for geometric changes or other signs of movement/instability.

- Uneven ground surface and/or equipment rutting was observed on the downstream perimeter dike crest near the Fly Ash Basin's southwest corner during previous inspections. The area exhibited relatively significant equipment rutting which appears to be the predominant contributor to the uneven ground condition. During Geosyntec's inspection, evidence of movement or instability, as previously defined, was not observed. Further observation to identify changes or other signs of movement/instability and/or regrading activities to smooth the slope for future inspections is recommended.

- In the northwest corner, a few minor ruts within the dike crest were observed. The perimeter road along the perimeter dike crest was generally observed to be in good condition with no observed signs of problematic desiccation or tension cracking and/or other deformations. Continued routine maintenance is recommended to permit access and facilitate routine inspection of the CCR unit.

- Occasional animal burrows between four to eight inches in diameter were observed on the southern and western -facing exterior dike slopes. Limited bare areas were observed on the exterior dike slopes with desiccation cracks. Extensive desiccation cracks or signs of seepage were not observed in these areas.

- Woody vegetation was observed on the interior of the berm on the western facing side and at the northeast corner of the Fly Ash Basin. Woody vegetation may lead to pathways of pond water infiltration through the berm, reducing the berm's structural integrity. However, at the time of the 2021 annual inspection, evidence of pond water infiltration through the berm was not observed. Woody vegetation is recommended to be removed from the interior of the berm as practicable and the localized area recompact after vegetation has been removed.

- An opening near the bottom of the perimeter fence was observed along the western boundary of the Fly Ash Basin. Burrowing animals may utilize this opening to access areas around the Fly Ash Basin. The opening at the bottom of the fence is recommended to be repaired to limit access to the Fly Ash Basin.

1. **Corrective Measure Repairs.** No corrective measure repairs are recommended at this time.
2. **Heightened Awareness During Routine Inspections.** This Report identifies a few areas that warrant close observation on a routine basis (i.e., weekly inspections) for signs of changes or progressive worsening of conditions. These areas were locations where wet/soft or uneven ground was observed. While there was no evidence of slope instability or movement, such conditions may be precursors. The southwest corner of the Fly Ash Basin was repaired in January 2020 during routine maintenance activities. A continuation of weekly inspections in this area is recommended for monitoring signs of changes.

3. **Ongoing Maintenance and Repairs as Needed.** Maintenance/repairs to the dikes and other appurtenant impoundment features should be performed on a routine and ongoing programmatic basis as well as on an as needed basis if warranted by problems or concerns (i.e., as identified during periodic inspections by a qualified person, or as otherwise identified). Grassy vegetation on the slopes of the berm should be maintained to promote visual inspections. Ruts should be regraded and bare areas should be re-seeded to establish vegetation, and the existing vegetation maintained in a condition to facilitate inspections. Observed ruts and erosion rills should be repaired before the feature worsens. Animal burrows should be filled with hydrated bentonite or equivalent material and covered with natural soil. Woody vegetation from the interior of the berms should be removed as practicable and the area recompacted following vegetation removal. Continue with current practices of maintaining set-back distance between CCR material stockpiles and the dikes.
