# **2022 CCR SURFACE IMPOUNDMENT ANNUAL INSPECTION REPORT**

## **Big Cajun II Power Plant Pointe Coupee Parish, Louisiana**

**Cleco Cajun, LLC**  
10431 Cajun II Road, Highway 981  
New Roads, Louisiana 70760

January 2023

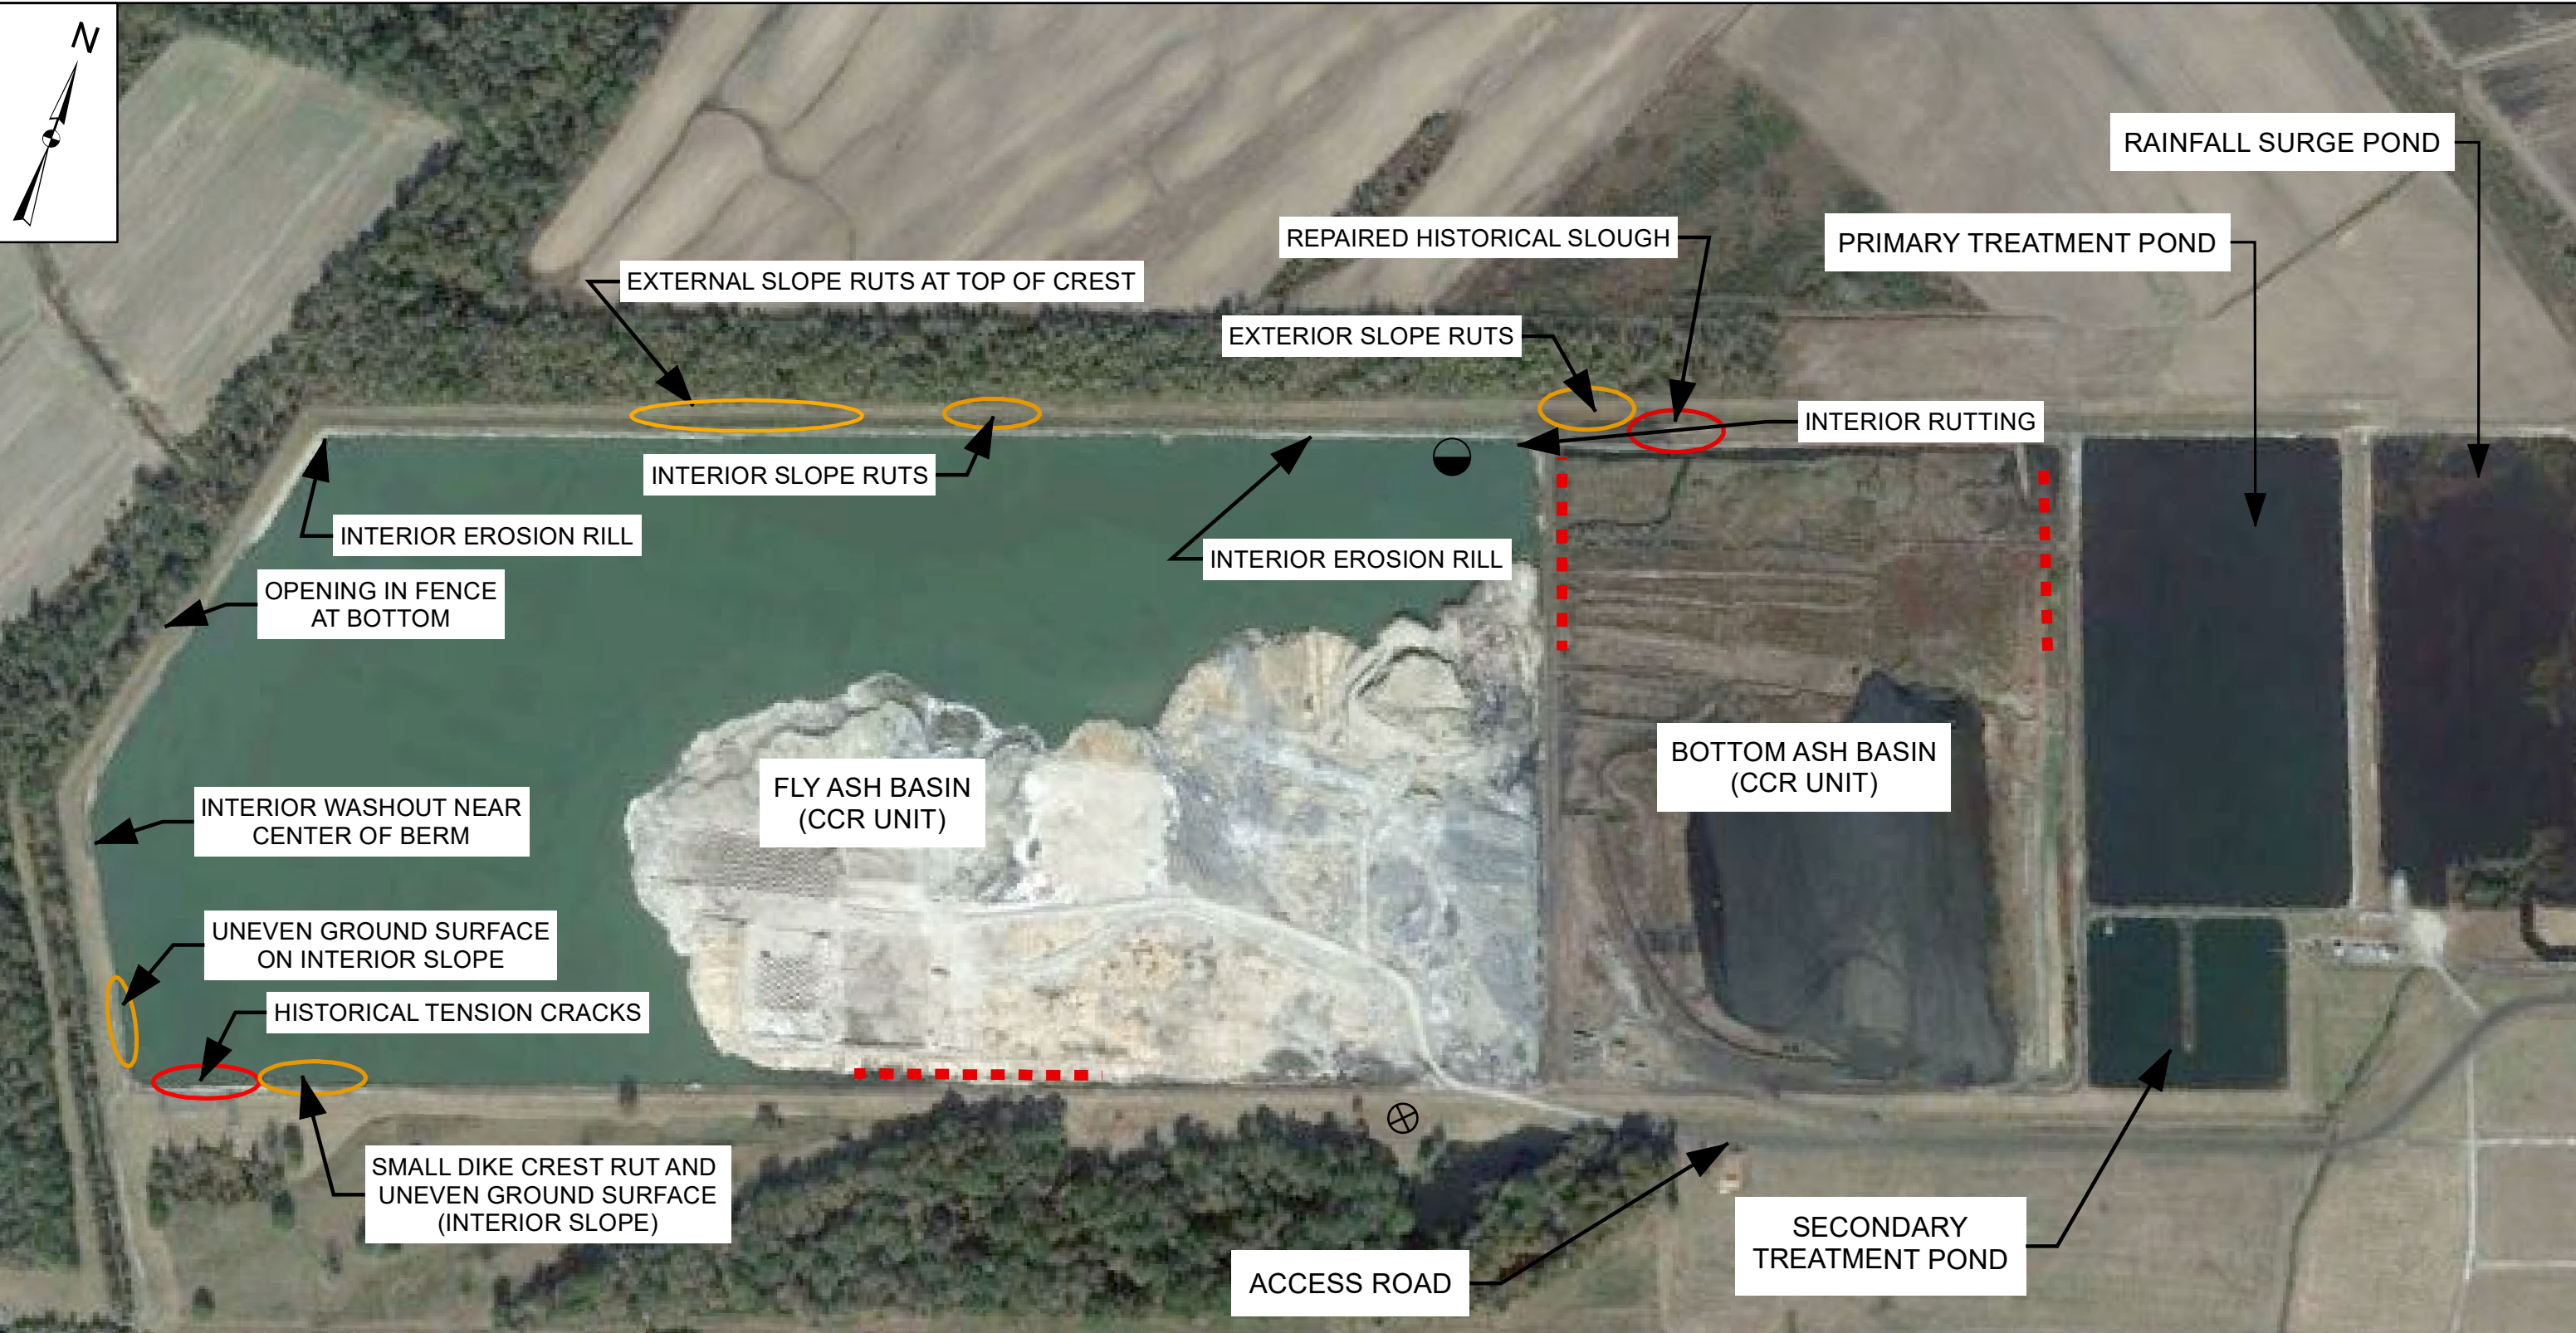
- A historical location of localized slope instability (a localized slough) on the north-facing exterior dike slope of the Bottom Ash Basin, about 400 feet east from the northwestern corner was identified during past annual inspections (CB&I, 2017; Geosyntec, 2018; Geosyntec, 2019; Geosyntec, 2020). The dimensions of the historical instability were approximately 70-ft to 90-ft long and exhibited a roughly 12-inch escarpment at the crest, that was slightly eroded with some vegetation. In January 2020, the Facility notified Geosyntec that a repair of this area was completed in December 2019. The repaired area did not appear to be displaced at the time of the inspection. Weekly inspection records indicate that the historical slough is monitored routinely, with no further evidence of displacement. At the time of the inspection, CCR material or a significant volume of standing water was not observed to be impounded on the interior perimeter dike slope adjacent to this area. As such, the former historical instability area appears to be a localized observation, that appears to have been adequately repaired prior to the 2020 annual inspection; and therefore, the area is not considered an issue that impairs the operation or safety of the CCR unit at this time.

- Woody vegetation was observed on the interior of the berm on the northwest and northeast sides of the Bottom Ash Basin. Woody vegetation has the potential to lead to pathways of infiltration through the berm, reducing the berm's structural integrity. However, at the time of the 2022 annual inspection, evidence of pond water infiltration through the berm was not observed. Woody vegetation is recommended to be removed from the interior of the berm as practicable and the localized area recompacted after vegetation has been removed.

- Surficial material on the interior slopes in several areas of the southwestern, western and northwestern dikes appear to be uneven resulting in localized steeper slopes near the crest. In some cases, rills extend near to the interior dike crest edge and/or are partially concealed by grassy vegetation. Maintenance of grassy vegetation on the interior slopes, further observation to identify changes, and/or regrading activities to smooth the interior slope is recommended.

- An area of uneven ground surface or a tension crack along the exterior about 250 feet east of the southwestern corner was observed in prior annual inspections. The southwest corner of the Fly Ash Basin was also previously identified as having potential sloughs/slope instability and was subsequently repaired. During this inspection, evidence of movement or instability (e.g., seepage, wet areas, and additional slumping) was not observed. The

- Uneven ground surface and/or equipment rutting was observed on the downstream perimeter dike crest near the Fly Ash Basin's southwest corner during previous inspections. The area exhibited relatively significant equipment rutting which appears to be the predominant contributor to the uneven ground condition. During Geosyntec's inspection, evidence of movement or instability, as previously defined, was not observed. Further observation to identify changes or other signs of movement/instability and/or regrading activities to smooth the slope for future inspections is recommended.

- In the northwest corner, a few minor ruts within the dike crest were observed. The perimeter road along the perimeter dike crest was generally observed to be in good condition with no observed signs of problematic desiccation or tension cracking and/or other deformations. Continued routine maintenance is recommended to permit access and facilitate routine inspection of the CCR unit.

- Occasional animal burrows between four to eight inches in diameter were observed on the southern-facing exterior dike slopes. No bare areas were observed on the exterior dike slopes with desiccation cracks. Extensive desiccation cracks or signs of seepage were not observed in these areas.

- Woody vegetation was observed on the interior of the berm on the southern facing side of the Fly Ash Basin. Woody vegetation may lead to pathways of pond water infiltration through the berm, reducing the berm's structural integrity. However, at the time of the 2022 annual inspection, evidence of pond water infiltration through the berm was not observed. Woody vegetation is recommended to be removed from the interior of the berm as practicable and the localized area recompacted after vegetation has been removed.

- An opening near the bottom of the perimeter fence was observed along the western boundary of the Fly Ash Basin. Burrowing animals may utilize this opening to access areas around the Fly Ash Basin. The opening at the bottom of the fence is recommended to be repaired to limit access to the Fly Ash Basin.

- The staff gauge located at the northeast corner of the Fly Ash Basin was functional, with a depth reading less than the lowest limit of the gauge. The staff gauge bent away from its supporting structure.

1. **Corrective Measure Repairs.** No corrective measure repairs are recommended at this time.
2. **Heightened Awareness During Routine Inspections.** This Report identifies a few areas that warrant close observation on a routine basis (i.e., weekly inspections) for signs of changes or progressive worsening of conditions. These areas were locations where wet/soft or uneven ground was observed. While there was no evidence of slope instability or movement, such conditions may be precursors. The southwest corner of the Fly Ash Basin was repaired in January 2020 during routine maintenance activities. A continuation of weekly inspections in this area is recommended for monitoring signs of changes.

3. **Ongoing Maintenance and Repairs as Needed.** Maintenance/repairs to the dikes and other appurtenant impoundment features should be performed on a routine and ongoing programmatic basis as well as on an as needed basis if warranted by problems or concerns (i.e., as identified during periodic inspections by a qualified person, or as otherwise identified). Grassy vegetation on the slopes of the berm should be maintained to promote visual inspections. Ruts should be regraded and bare areas should be re-seeded to establish vegetation, and the existing vegetation maintained in a condition to facilitate inspections. Observed ruts and erosion rills should be repaired before the feature worsens. Animal burrows should be filled with hydrated bentonite or equivalent material and covered with natural soil. Woody vegetation from the interior of the berms should be removed as practicable and the area recompacted following vegetation removal. Continue with current practices of maintaining set-back distance between CCR material stockpiles and the dikes. Ensure that the staff gauge is fully secured to its supporting structure. Repair openings in perimeter fencing when identified.
