# 2023 CCR SURFACE IMPOUNDMENT ANNUAL INSPECTION REPORT

## Big Cajun II Power Plant Pointe Coupee Parish, Louisiana

Project Number TXR9160B

January 2024

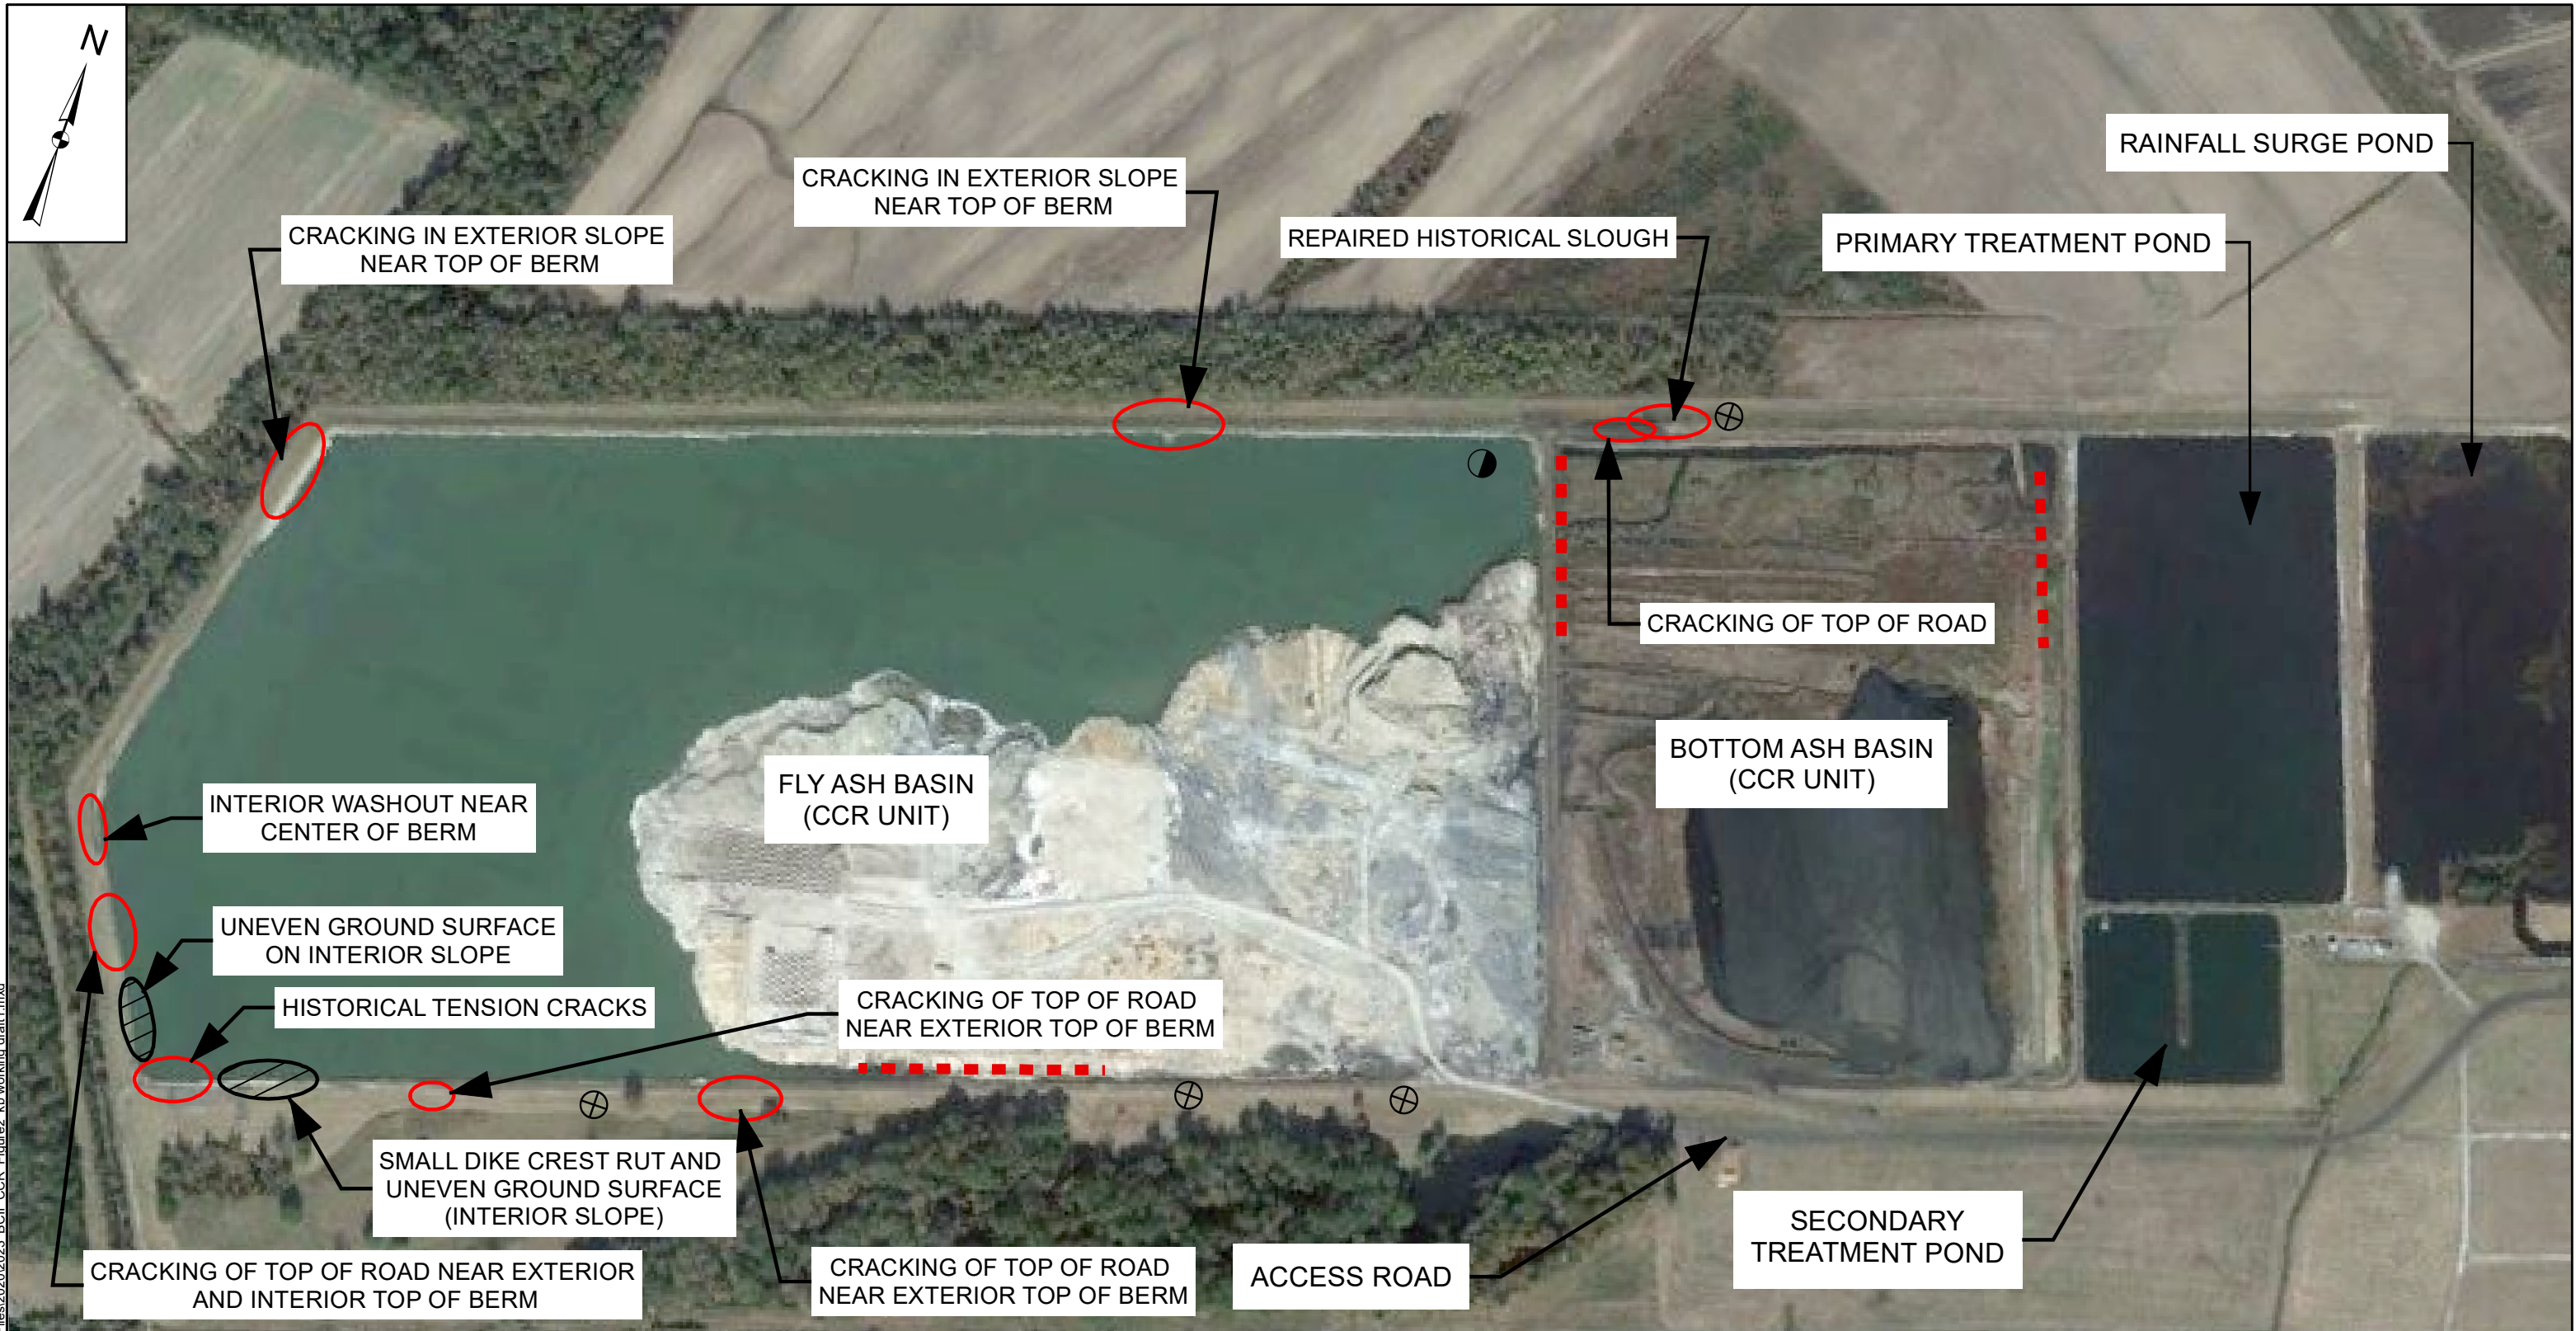
- A historical location of localized slope instability (a localized slough) on the north-facing exterior dike slope of the Bottom Ash Basin, about 400 feet east from the northwestern corner was identified during past annual inspections (CB&I, 2017; Geosyntec, 2018; Geosyntec, 2019; Geosyntec, 2020). The dimensions of the historical instability were approximately 70-ft to 90-ft long and exhibited a roughly 12-inch escarpment at the crest, that was slightly eroded with some vegetation. In January 2020, the Facility notified Geosyntec that a repair of this area was completed in December 2019. The repaired area did not appear to be displaced at the time of the inspection. Weekly inspection records indicate that the historical slough is monitored routinely, with no further evidence of displacement. At the time of the inspection, neither CCR material nor standing water was observed to be impounded on the interior perimeter dike slope adjacent to this area. As such, the former historical instability area appears to be a localized observation, that appears to have been adequately repaired prior to the 2020 annual inspection; and therefore, the area is not considered an issue that impairs the operation or safety of the CCR unit at this time.

- The perimeter road on top of the dike was generally in good condition with one area near the northwest corner showing signs of desiccation cracking at the center of the road.

- One animal burrow between four to eight inches in diameter was observed on the northern-facing exterior dike slope.
- Standing water was observed and was located predominantly along drainage swales on the northern and eastern sides, where CCR placement within the Bottom Ash Basin is set-back from the perimeter dikes. During the inspection, process water was channelized towards the southeast corner of the impoundment. Temporary diesel driven pumps were present around the Bottom Ash Basin but were not operational during the inspection. Process water was pumped into the south end of the basin. The hydraulic structure conditions are discussed subsequently within this Report.

- Woody vegetation was observed on the interior of the berm on the northwest and northeast sides of the Bottom Ash Basin. Woody vegetation has the potential to lead to pathways of infiltration through the berm, reducing the berm's structural integrity. At the time of the 2023 annual inspection, evidence of pond water infiltration through the berm was not observed. Woody vegetation is recommended to be removed from the interior of the berm as practicable and the localized area recompacted after vegetation has been removed.

- Surficial material on the interior slopes in several areas of the southwestern and western dikes appear to be uneven resulting in localized steeper slopes near the crest. In some cases, rills extend near to the interior dike crest edge and/or are partially concealed by grassy vegetation. Maintenance of grassy vegetation on the interior slopes, further observation to identify changes, and/or regrading activities to smooth the interior slope is recommended.

- An area of uneven ground surface or a tension crack along the exterior about 250 feet east of the southwestern corner was observed in prior annual inspections. The southwest corner of the Fly Ash Basin was also previously identified as having potential sloughs/slope instability and was subsequently repaired. During this inspection, evidence of movement or instability (e.g., seepage, wet areas, and additional slumping) was not observed. The area merits continued annual inspection and observation weekly for geometric changes or other signs of movement/instability.

- Uneven ground surface and/or equipment rutting was observed on the downstream perimeter dike crest near the Fly Ash Basin’s southwest corner during previous inspections. The area exhibited equipment rutting which appeared to be the predominant contributor to the uneven ground condition. During Geosyntec’s inspection, evidence of movement or instability, as previously defined, was not observed. Further observation to identify changes or other signs of movement/instability and/or regrading activities to smooth the slope for future inspections is recommended.

- Desiccation cracks were observed at the southern, southwestern, northwestern, and northern dikes at the exterior top of slope and at the southwestern dike at the interior top of slope. Seepage of the dike at these areas was not observed. The desiccation cracks should be filled in and further observation to monitor for expansion of the desiccation cracks is recommended.

- Occasional animal burrows between four to eight inches in diameter were observed on the southern-facing exterior dike slopes. No bare areas were observed on the exterior dike slopes with desiccation cracks. Extensive desiccation cracks or signs of seepage were not observed in these areas.

- Woody vegetation was observed on the interior of the berm on the southern facing side of the Fly Ash Basin. Woody vegetation may lead to pathways of pond water infiltration through the berm, reducing the berm’s structural integrity. At the time of the 2023 annual inspection, evidence of pond water infiltration through the berm was not observed. Woody vegetation is recommended to be removed from the interior of the berm, as practicable, and the localized area recompacted after vegetation has been removed.

1. **Corrective Measure Repairs.** Geosyntec recommends the desiccation cracks be filled with a suitable material to limit saturation of the dike if the cracks have not been closed by additional rainfall following the inspection.

2. **Heightened Awareness During Routine Inspections.** This Report identifies a few areas that warrant close observation on a routine basis (i.e., weekly inspections) for signs of changes or progressive worsening of conditions (e.g., development of additional or expansion of desiccation cracks). These areas include locations where wet/soft ground, uneven ground, or cracking was observed. While there was no evidence of slope instability or movement, such conditions may be precursors. The southwest corner of the Fly Ash Basin was repaired in January 2020 during routine maintenance activities. A continuation of weekly inspections in this area is recommended for monitoring signs of changes.
