# 2024 CCR SURFACE IMPOUNDMENT ANNUAL INSPECTION REPORT

## Big Cajun II Power Plant Pointe Coupee Parish, Louisiana

Geosyntec Consultants, Inc.  
2600 CitiPlace Court, Suite 500  
Baton Rouge, Louisiana 70808

January 2025

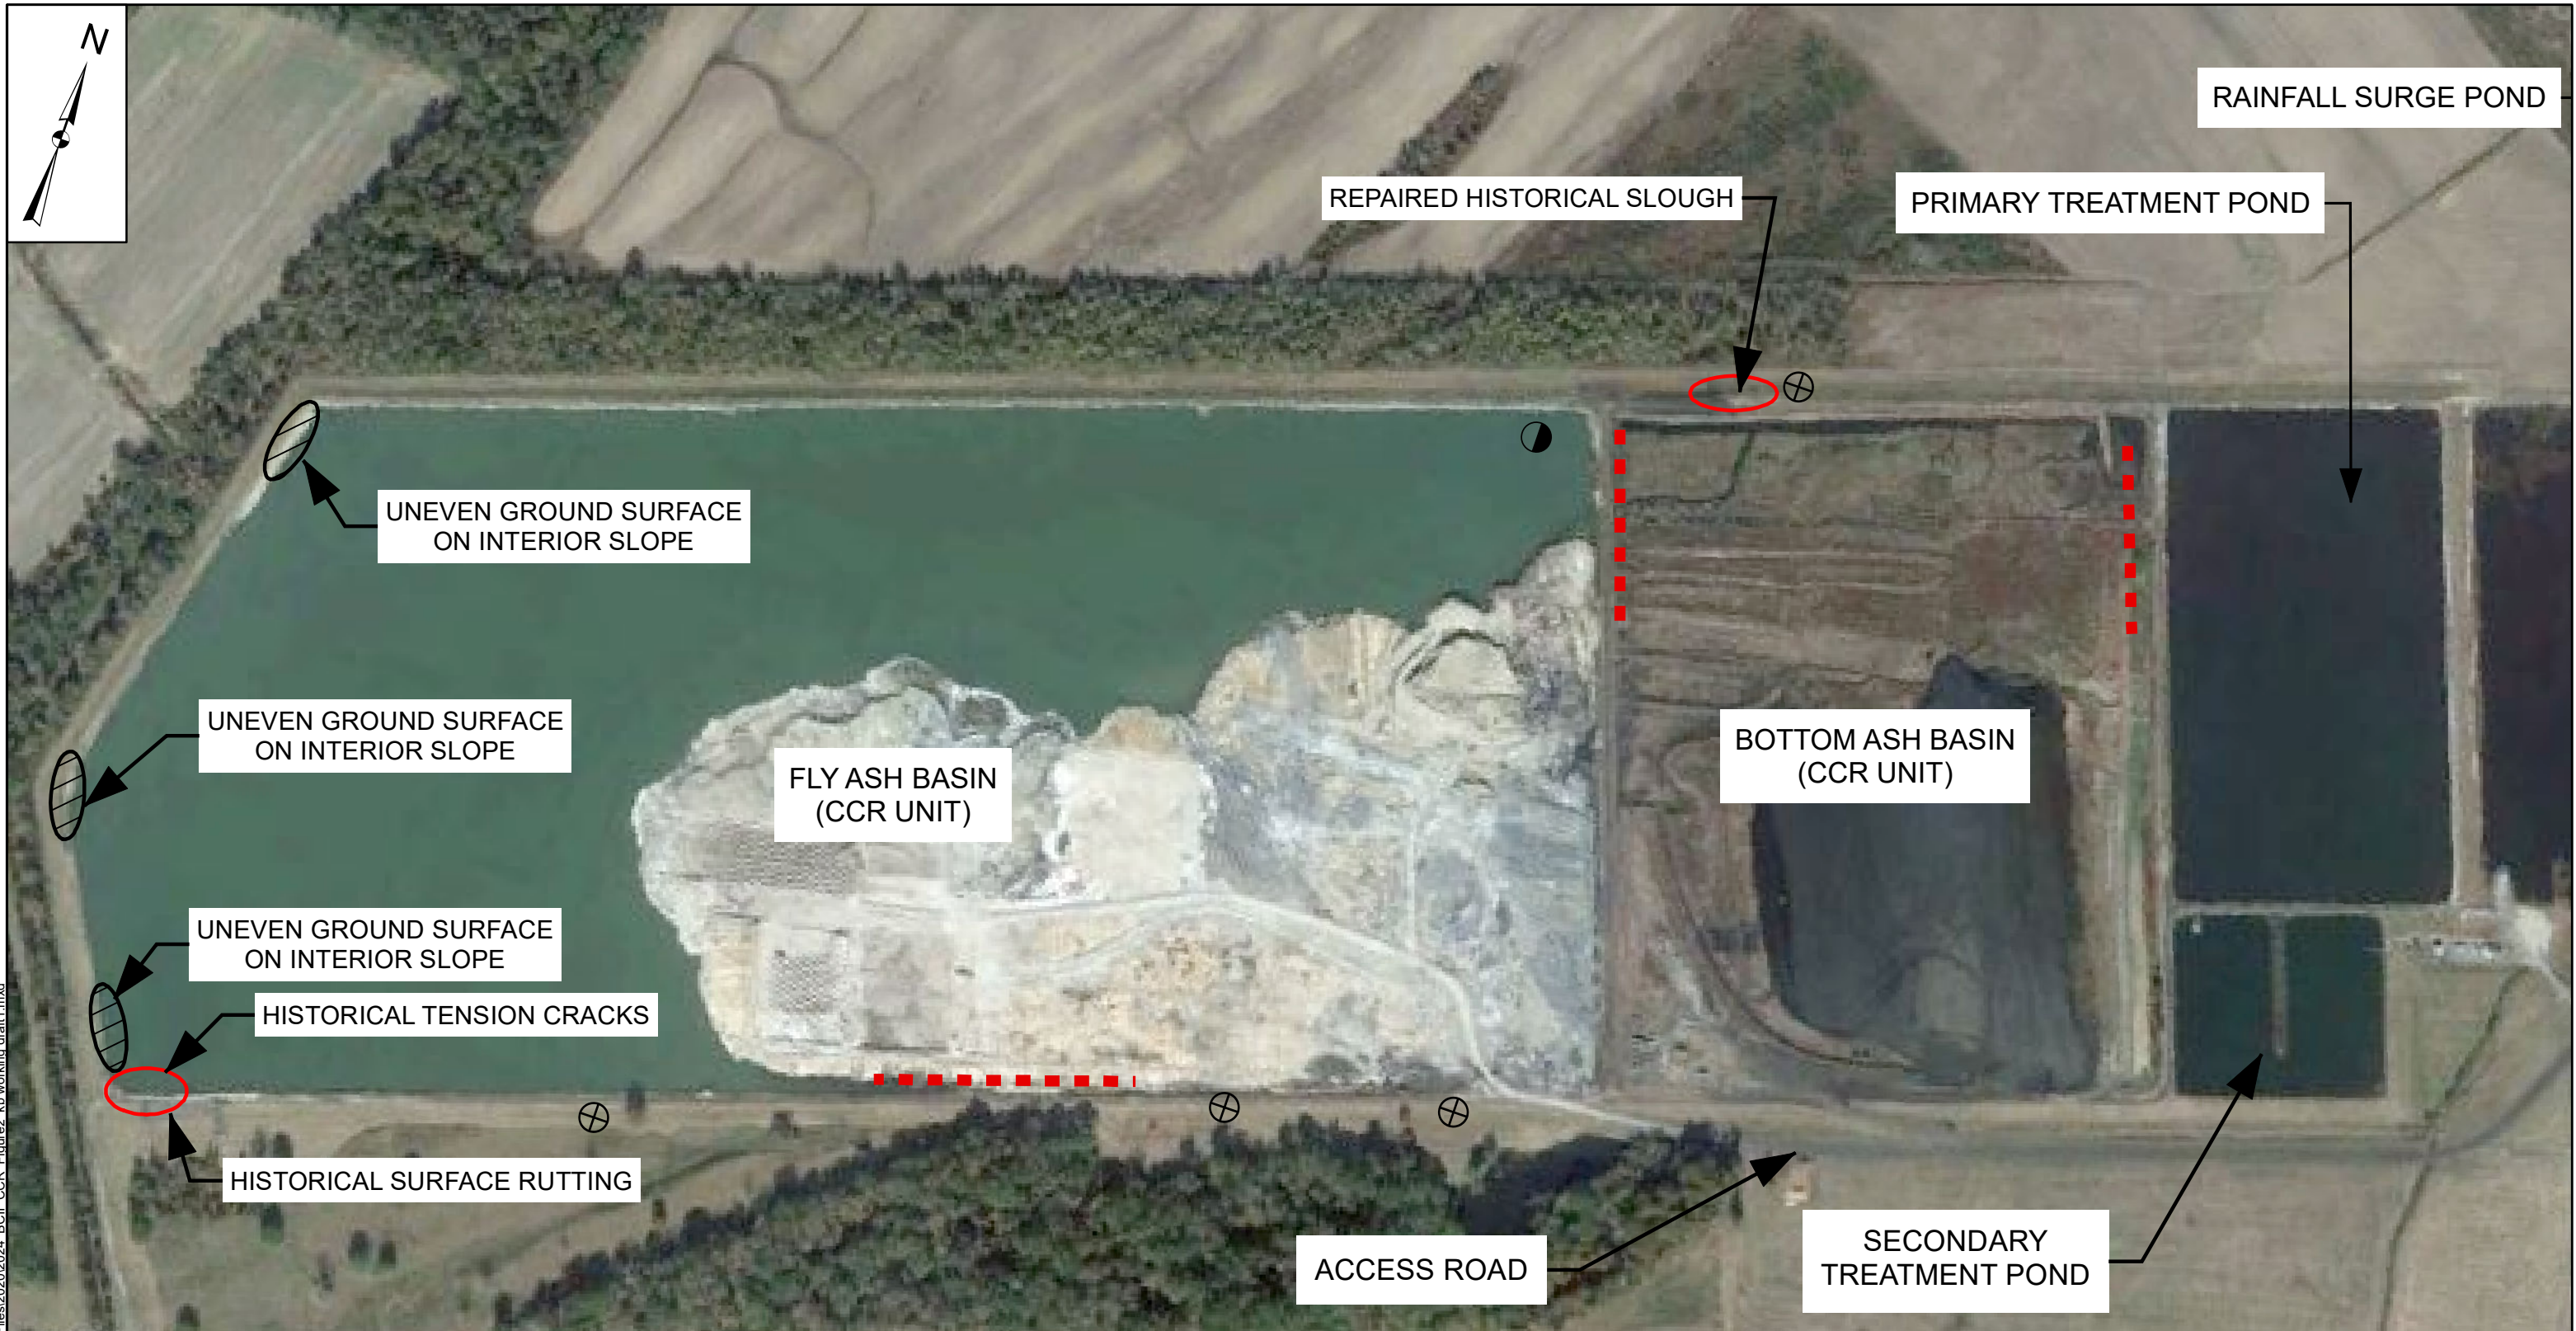
- A historical location of localized slope instability (a localized slough) on the north-facing exterior dike slope of the Bottom Ash Basin, about 400 feet east from the northwestern corner was identified during past annual inspections (CB&I, 2017; Geosyntec, 2018; Geosyntec, 2019; Geosyntec, 2020). The dimensions of the historical instability were approximately 70-ft to 90-ft long and exhibited a roughly 12-inch escarpment at the crest, that was slightly eroded with some vegetation. In January 2020, the Facility notified Geosyntec that a repair of this area was completed in December 2019. The repaired area did not appear to be displaced at the time of the inspection. Weekly inspection records indicate that the historical slough is monitored routinely, with no further evidence of displacement. At the time of the inspection, neither CCR material nor standing water was observed to be impounded on the interior perimeter dike slope adjacent to this area. As such, the former historical instability area appears to be a localized observation, that appears to have been adequately repaired prior to the 2020 annual inspection; and therefore, the area is not considered an issue that impairs the operation or safety of the CCR unit at this time.

- One animal burrow between four to eight inches in diameter was observed on the northern-facing exterior dike slope.
- Standing water was observed and was located predominantly along drainage swales on the northern and eastern sides, where CCR placement within the Bottom Ash Basin is set-back from the perimeter dikes. During the inspection, process water was channelized towards the southeast corner of the impoundment. Temporary diesel driven pumps were present around the Bottom Ash Basin but were not operational during the inspection. Process water was pumped into the south end of the basin. The hydraulic structure conditions are discussed subsequently within this Report.

- Woody vegetation was observed on the interior of the berm on the northwest and northeast sides of the Bottom Ash Basin. Woody vegetation has the potential to lead to pathways of infiltration through the berm, reducing the berm's structural integrity. At the time of the 2024 annual inspection, evidence of pond water infiltration through the berm was not observed. Woody vegetation is recommended to be removed from the interior of the berm as practicable and the localized area recompacted after vegetation has been removed.

- Surficial material on the interior slopes in several areas of the southwestern and western dikes appear to be uneven resulting in localized steeper slopes near the crest. In some cases, rills extend near to the interior dike crest edge and/or are partially concealed by grassy vegetation. Maintenance of grassy vegetation on the interior slopes, further observation to identify changes, and/or regrading activities to smooth the interior slope is recommended.

- An area of uneven ground surface or a tension crack along the exterior about 250 feet east of the southwestern corner was observed in prior annual inspections. The southwest corner of the Fly Ash Basin was also previously identified as having potential sloughs/slope instability and was subsequently repaired. During this inspection, evidence of movement or instability (e.g., seepage, wet areas, and additional slumping) was not observed. The

- Uneven ground surface and/or equipment rutting was observed on the downstream perimeter dike crest near the Fly Ash Basin's southwest corner during previous inspections. The area exhibited equipment rutting which appeared to be the predominant contributor to the uneven ground condition. During Geosyntec's inspection, evidence of movement or instability, as previously defined, was not observed. Further observation to identify changes or other signs of movement/instability and/or regrading activities to smooth the slope for future inspections is recommended.

- Occasional animal burrows between four to eight inches in diameter were observed on the southern-facing exterior dike slopes. No bare areas were observed on the exterior dike slopes with desiccation cracks. Extensive desiccation cracks or signs of seepage were not observed in these areas.

- Woody vegetation was observed on the interior of the berm on the southern facing side of the Fly Ash Basin. Woody vegetation may lead to pathways of pond water infiltration through the berm, reducing the berm's structural integrity. At the time of the 2024 annual inspection, evidence of pond water infiltration through the berm was not observed. Woody vegetation is recommended to be removed from the interior of the berm, as practicable, and the localized area recompact after vegetation has been removed.

1. **Corrective Measure Repairs.** No corrective measures are recommended at this time.
2. **Heightened Awareness During Routine Inspections.** This Report identifies a few areas that warrant close observation on a routine basis (i.e., weekly inspections) for signs of changes or progressive worsening of conditions (e.g., development of additional or expansion of desiccation cracks). These areas include locations where wet/soft ground, uneven ground, or cracking was observed. While there was no evidence of slope instability or movement, such conditions may be precursors. The southwest corner of the Fly Ash Basin was repaired in January 2020 during routine maintenance activities. A continuation of weekly inspections in this area is recommended for monitoring signs of changes.

3. **Ongoing Maintenance and Repairs as Needed.** Maintenance/repairs to the dikes and other appurtenant impoundment features should be performed on a routine and ongoing programmatic basis. Maintenance/repair should be performed as needed if warranted by observed problems or concerns (i.e., as identified during periodic inspections by a qualified person, or as otherwise identified). Grassy vegetation on the slopes of the berm should be maintained to promote visual inspections. Ruts should be regraded and bare areas should be re-seeded to establish vegetation, and the existing vegetation maintained in a condition to facilitate inspections. Observed ruts and erosion rills should be repaired before the feature worsens. Animal burrows should be filled with hydrated bentonite or equivalent material and covered with natural soil. Woody vegetation from the interior of the berms should be removed as practicable and the area recompact following vegetation removal. Desiccation cracks should be monitored for and filled if rainfall does not result in closure of the cracks. Continue with current practices of maintaining set-back distance between CCR material stockpiles and the dikes. Ensure that the staff gauge is fully secured to its supporting structure. Repair openings in perimeter fencing when identified.
